Manhole Inspection Summary

Manhole # S29S1_008MH

Location Address: **2941 Denham Cir.**

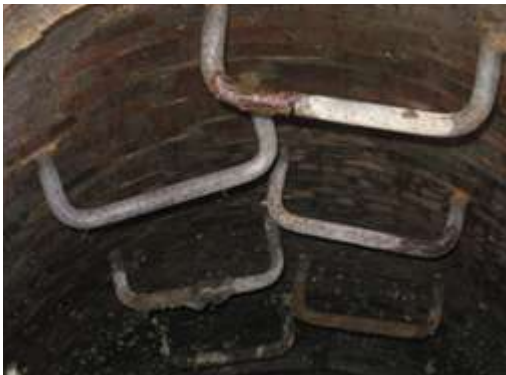
Steps Count: **8** Missing: **0** ☒ **Corroded**

steps

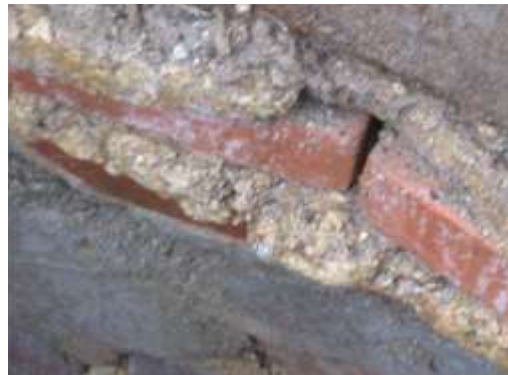
Defect 1

Condition: ☐ Sound ☐ Cracked ☐ Root Intrusion ☒ **Loose Brick** ☐ Deteriorated

Infiltration: ☐ None ☐ Joint ☐ Cracks ☒ **Mortar** ☐ Roots ☐ Wall

loose bricks/mortar on chimney

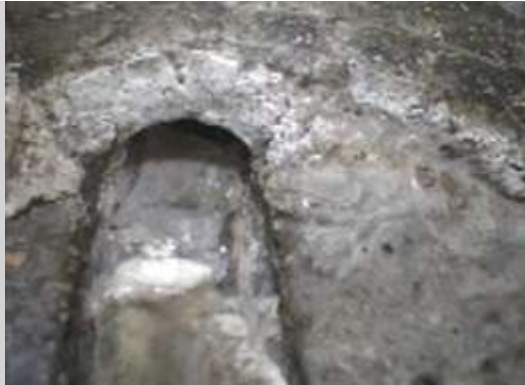
12 O'Clock Outflow

8 in. Circular Gravity Sewer
Pipe Out @ 12 O'Clock

Pipe Height: **10.8** (in.) Rod and Bar (Angled)
Pipe Material: **Clay** ☐ Pipe Lined
Invert Depth: **12.24** (ft.) Flow Characteristics: **Slow**
Deposits: ☒ None ☐ Mud ☐ Sludge ☐ Debris ☐ Grease
Silt Depth: (in.) Deposits Extent:
Infiltration: **None** Pipe Seal Cond: **Sound**

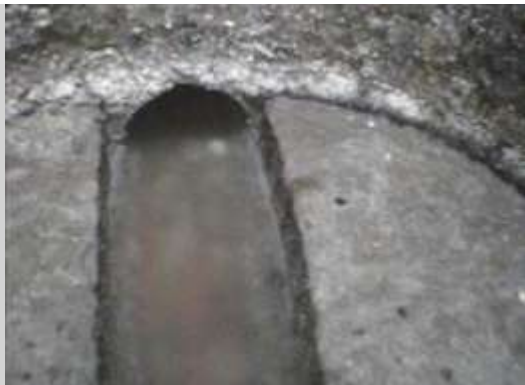
6 O'Clock Inflow

8 in. Circular Gravity Sewer
Pipe In @ 6 O'Clock

Pipe Height: **10.8** (in.) Rod and Bar (Angled)
Pipe Material: **Clay** ☐ Pipe Lined
Invert Depth: **12.14** (ft.) Flow Characteristics: **Slow**
Deposits: ☒ None ☐ Mud ☐ Sludge ☐ Debris ☐ Grease
Silt Depth: (in.) Deposits Extent:
Infiltration: **None** Pipe Seal Cond: **Sound**
